<b>Report To:</b>	<b>Environment &amp; Regeneration Committee</b>	<b>Date:</b>	<b>29 August 2019</b>
<b>Report By:</b>	<b>Corporate Director Environment, Regeneration &amp; Resources</b>	<b>Report</b>	<b>LP/104/19</b>
<b>Contact Officer:</b>	<b>Alan McClintock</b>	<b>Contact No:</b>	<b>01475 712444</b>
<b>Subject:</b>	<b>King George VI Building – 9-11 King Street, Port Glasgow</b>

- 1.1 The purpose of this report is to update the Committee on the structural condition of the King George VI building and the reasons for temporarily suspending the Works.

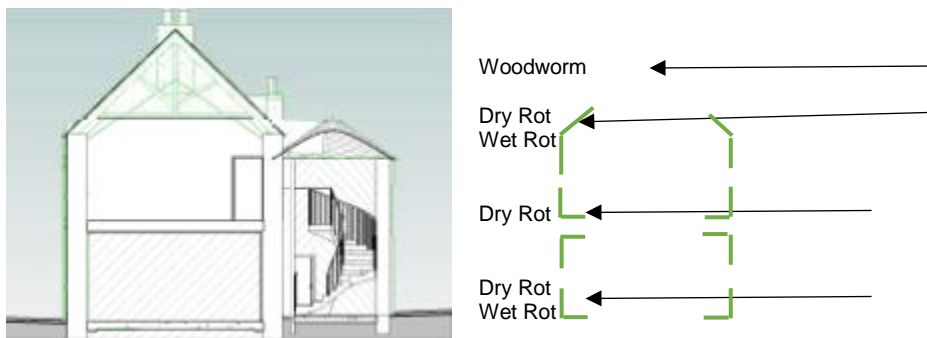
Diagram 1

- 4.4 It was reported to the Committee on 2 May 2019 that the Phase 1 works had identified significant dry rot, wet rot and woodworm and that most of the timbers would have to be stripped out. See diagram 1. The Committee approved the reorganisation of works between the phases and that some of the residual funding for Phase 2 would be used in Phase 1. The estimated project cost of Phase 1 would be £730,000. The residual funding was therefore £270,000 and to be expended on Phase 2.

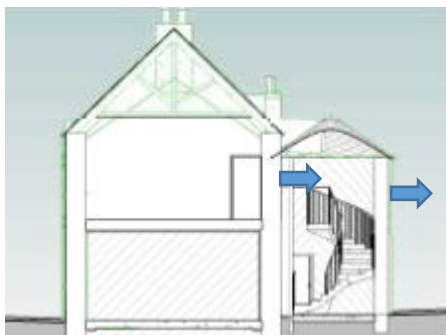
Diagram 2

- 4.6 It was also reported that the spiral stair had a significant lean, is considered dangerous and we would discuss remedial action with Historic Environment Scotland (HES) and to delay any work to the stair until Phase 2. HES has now confirmed that we can demolish the stair.
- 4.7 With the removal of most of the timbers and by hacking back the render over the stonework we have discovered additional structural distress to the building which will result in demolition of most of the rear wall including the spiral stair and this work must be undertaken in Phase 1 for safety reasons.
- 4.8 The spiral stair is leaning out but we have now established that it is pulling out part of the rear wall. See diagram 2 and 3 and photograph 1.

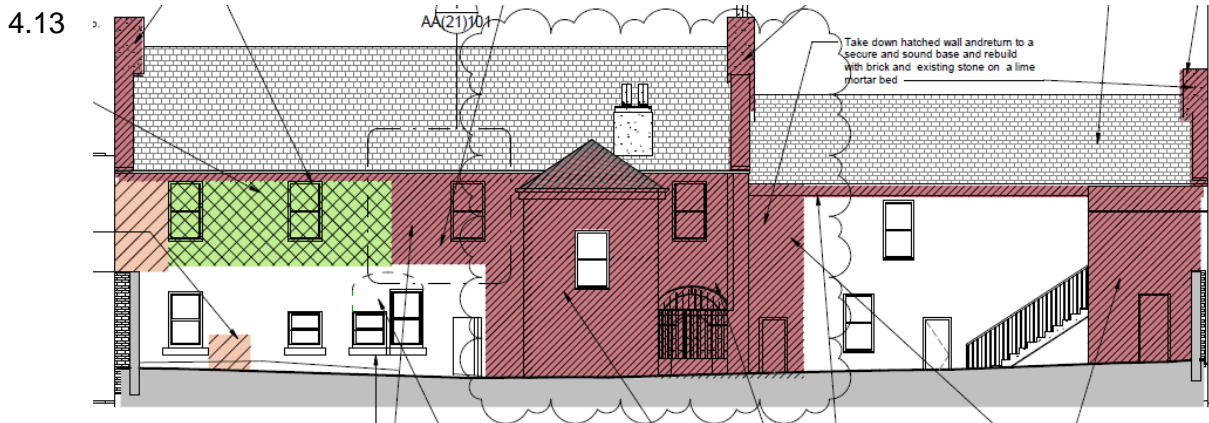
Diagram 4 Rear Elevation

4.12 A detailed survey of the structural integrity of the rear wall has now established that a significant part of the rear wall must be removed and rebuilt. See Diagram 4.

4.15 A significantly expensive element is the stone restoration to the rear of the building. We are currently undertaking value engineering to find ways of rebuilding the defective stone walls more economically. Should this be possible, agreed by HES, and contained within the existing budget we will recommence the works. Should this not be possible within the budget we will prepare a report to the next committee cycle outlining options and costs.
