Report To:	Environment & Regeneration Committee	Date:	31 October 2019
Report By:	Corporate Director Environment, Regeneration & Resources	Report No:	LP/124/19
Contact Officer:	Alan McClintock	Contact No:	01475 712444
Subject:	King George VI Building – 9-11 King Street, Port Glasgow

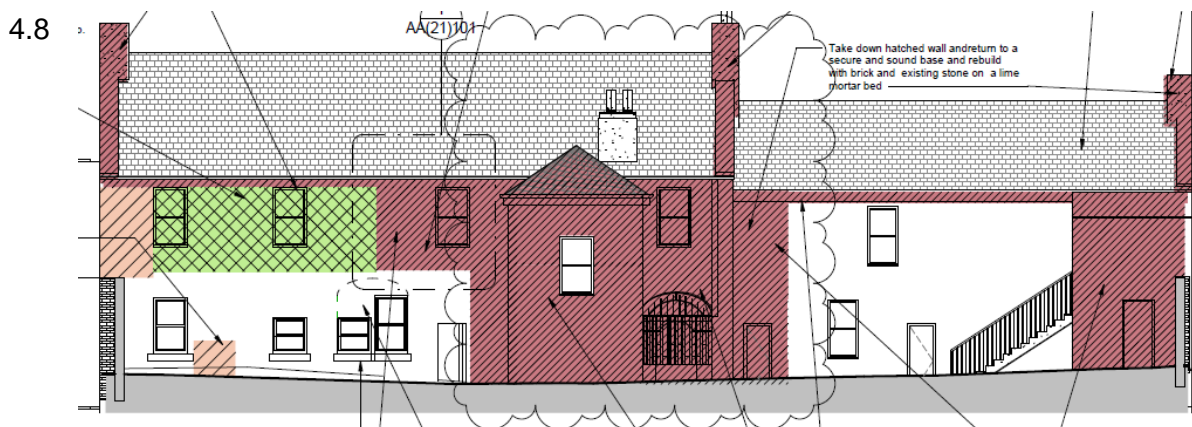
Diagram 1 Rear Elevation

- 4.4 It was reported to the Committee on 2 May 2019 that the Phase 1 works had identified significant dry rot, wet rot and woodworm and that most of the timbers would have to be stripped out. See diagram 1. The Committee approved the reorganisation of works between the phases and agreed that some of the residual funding for Phase 2 would be used in Phase 1. The estimated project cost of Phase 1 would be £730,000. The residual funding was therefore £270,000 and to be expended on Phase 2.

- 4.6 With the removal of most of the timbers and by hacking back the render over the stonework we have discovered additional structural distress to the building which will result in demolition of most of the rear wall, including the spiral stair, and this work must be undertaken in Phase 1 for safety reasons.

- 4.7 A detailed survey of the structural integrity of the rear wall has now established that a significant part of the rear wall must be removed and rebuilt. This is illustrated as all the shaded areas in Diagram 1.

- Partial demolition of the three gable walls and rebuilding in brick. The exposed gables above the roof line to be rendered.
- Partial demolition of the rear wall as illustrated in Diagram 1 (paragraph 4.8).
- Salvaged stone to be used for the rebuilding of the arched area. Remaining walls to be rebuilt in brick.
- Rear elevation to be rendered.
- Spiral stair to be demolished and replaced at a later date subject to funding.
- Stair to Masonic Hall to be retained for temporary access although access lobby to be removed.
- Flooring to be removed and joists installed to create single upper floor level. Temporary floor boarding installed for safe access.
- Several roof trusses at the Masonic side to be retained and additional trusses installed to replace removed trusses throughout.
- All roofs to have sarking, felt and slate finish.
